**Preservation Management Plan
for the
Elm Street Cemetery
Braintree, Massachusetts
Volume II: Treatment Proposals**

Prepared for:
The City of Braintree
Braintree, Massachusetts
February, 2011

VOLUME II – TREATMENT PROPOSALS

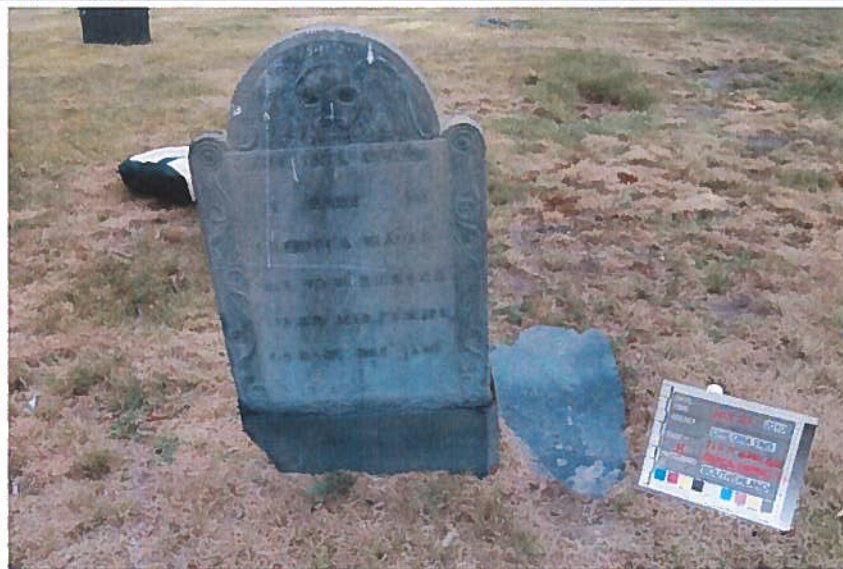
Section: H

Position: ☐ fallen ☐ tilted ☒ unstable ☒ unattached/loose ☐ missing

Legibility: ☐ sharp, tooling evident ☐ clear, but worn ☒ partially discernable ☐ not discernable

Failed/Old Treatments: ☐ metal ☐ adhesives/coatings ☒ mortar ☐ other:

Soiling: ☒ biological ☐ staining ☐ efflorescence ☐ other:

Position: ☐ reset/level in ground ☒ reset/level to existing base ☐ construct new base ☐ resquare
☐ possible new base required ☐ stabilize foundation ☐ reset with NHL 3.5 1:2.5 mix ☐ reset with compound

Failed Treatments: ☐ drill/grind ☒ hand tools ☐ solvents ☐ other:

Treatment: ☐ core drill ☒ drill and pin ☐ simple adhesive repair ☐ injection grout ☐ replace bricks
☐ infill losses ☐ repoint ☒ other: consolidate with HCT

Cost: \$800

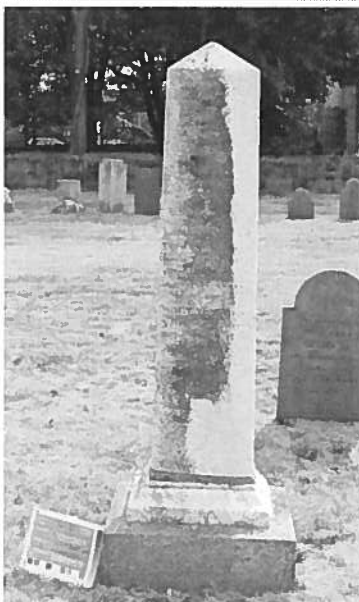
Section: H

Position: ☒ fallen ☐ tilted ☐ unstable ☐ unattached/loose ☐ missing

Legibility: ☐ sharp, tooling evident ☐ clear, but worn ☒ partially discernable ☐ not discernable

Deterioration: ☒ broken ☐ cracked ☐ losses ☐ flaking/sugaring ☐ ferrous pins ☐ brass pins
☐ delamination/detachment ☐ spalling ☐ missing fragments ☒ other: mower damage

Soiling: ☒ biological ☐ staining ☐ efflorescence ☐ other:

Position: ☐ reset/level in ground ☒ reset/level to existing base ☐ construct new base ☐ resquare
☐ possible new base required ☐ stabilize foundation ☐ reset with NHL 3.5 1:2.5 mix ☐ reset with compound

Treatment: ☐ core drill ☒ drill and pin ☐ simple adhesive repair ☐ injection grout ☐ replace bricks
☒ infill losses ☐ repoint ☒ other: consolidate with HCT

Cost: \$1000

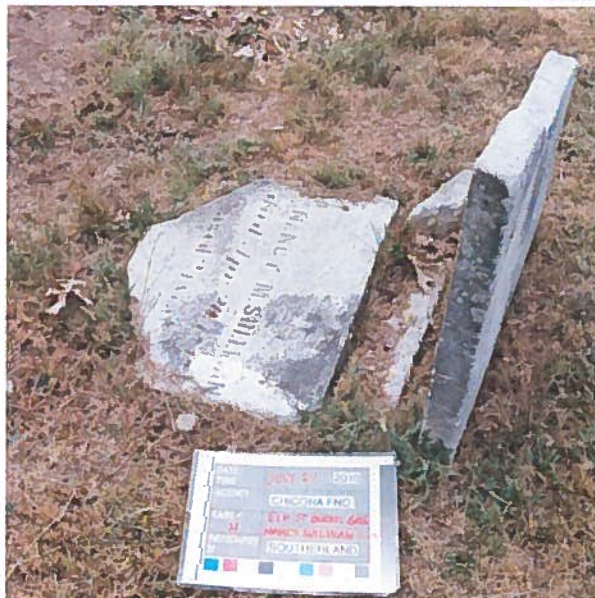
Section: H

Legibility: ☐ sharp, tooling evident ☐ clear, but worn ☒ partially discernable ☐ not discernable

Deterioration: ☒ broken ☐ cracked ☐ losses ☐ flaking/sugaring ☐ ferrous pins ☐ brass pins
☐ delamination/detachment ☐ spalling ☐ missing fragments ☒ other: heavy weathering

Soiling: ☒ biological ☐ staining ☐ efflorescence ☐ other:

Position: ☐ reset/level in ground ☒ reset/level to existing base ☐ construct new base ☐ resquare
☐ possible new base required ☐ stabilize foundation ☐ reset with NHL 3.5 1:2.5 mix ☐ reset with compound

Treatment: ☐ core drill ☒ drill and pin ☐ simple adhesive repair ☐ injection grout ☐ replace bricks
☒ infill losses ☐ repoint ☒ other: consolidate with HCT

Cost: \$900

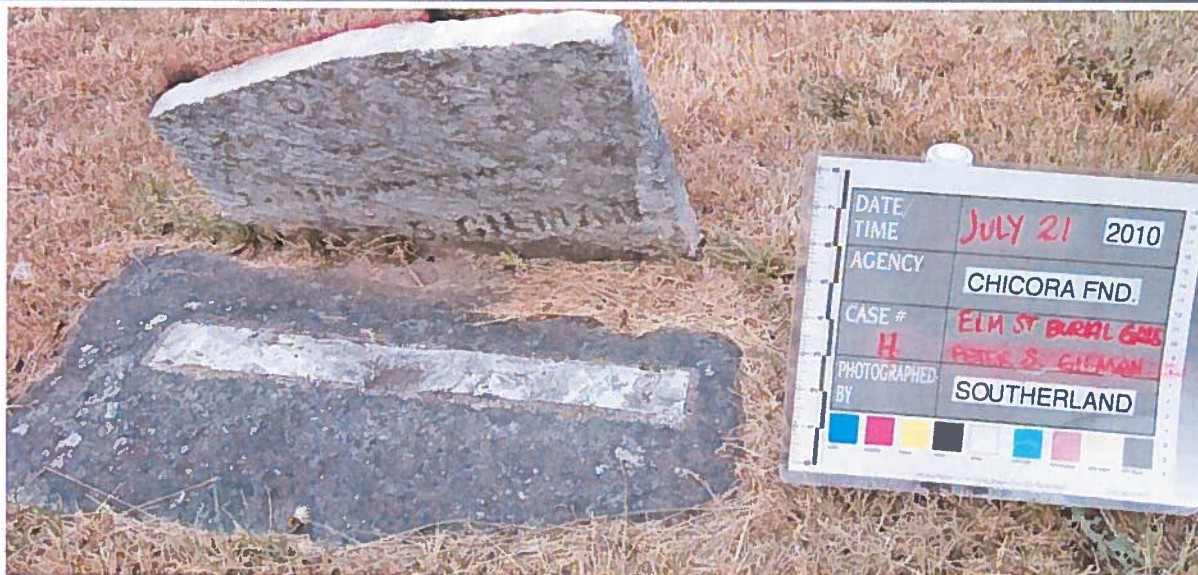
Section: I

Deterioration: ☐ broken ☒ cracked ☐ losses ☐ flaking/sugaring ☐ ferrous pins ☐ brass pins
☐ delamination/detachment ☐ spalling ☐ missing fragments ☐ other:

Soiling: ☒ biological ☐ staining ☐ efflorescence ☐ other:

Treatment: ☐ core drill ☐ drill and pin ☐ simple adhesive repair ☐ injection grout ☐ replace bricks
☐ infill losses ☐ repoint ☒ other: schedule reinspection

Cost: \$100

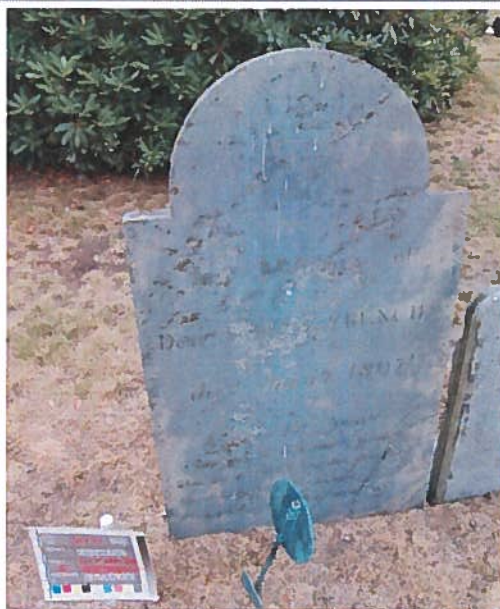
Section: I

Position: ☒ fallen ☐ tilted ☐ unstable ☐ unattached/loose ☐ missing ☒ moved behind headstone

Legibility: ☒ sharp, tooling evident ☐ clear, but worn ☐ partially discernable ☐ not discernable

Deterioration: ☒ broken ☐ cracked ☐ losses ☐ flaking/sugaring ☐ ferrous pins ☐ brass pins
☐ delamination/detachment ☐ spalling ☐ missing fragments ☐ other:

Soiling: ☒ biological ☐ staining ☐ efflorescence ☐ other:

Position: ☐ reset/level in ground ☐ reset/level to existing base ☐ construct new base ☐ resquare
☐ possible new base required ☐ stabilize foundation ☐ reset with NHL 3.5 1:2.5 mix ☐ reset with
compound ☒ reset/level in ground ca. 5' behind headstone

Treatment: ☐ core drill ☐ drill and pin ☒ simple adhesive repair ☐ injection grout ☐ replace bricks
☒ infill losses ☐ repoint ☐ other:

Cost: \$300

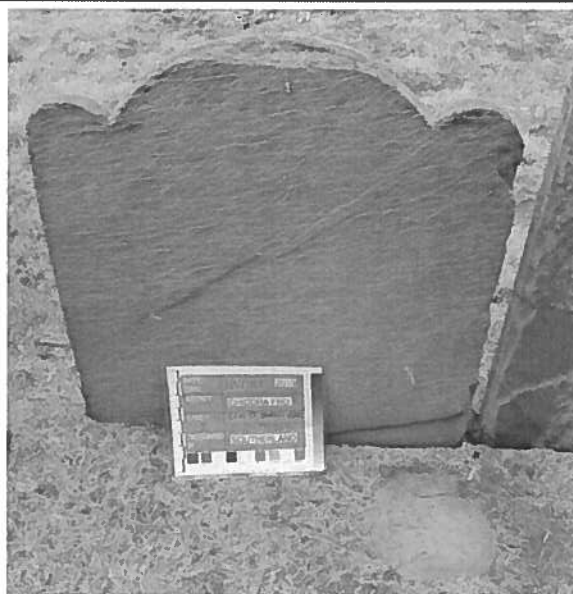
Section: I

Legibility: ☐ sharp, tooling evident ☒ clear, but worn ☐ partially discernable ☐ not discernable

Deterioration: ☐ broken ☒ cracked ☐ losses ☐ flaking/sugaring ☐ ferrous pins ☐ brass pins
☐ delamination/detachment ☐ spalling ☐ missing fragments ☒ other: damage from lichen

Soiling: ☒ biological ☐ staining ☐ efflorescence ☐ other:

Cost: \$100

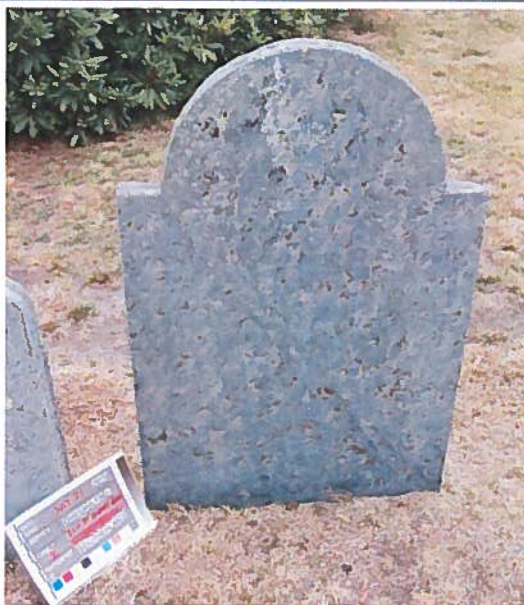
Section: I

Position: ☐ fallen ☒ tilted ☐ unstable ☐ unattached/loose ☐ missing

Deterioration: ☐ broken ☐ cracked ☐ losses ☐ flaking/sugaring ☐ ferrous pins ☐ brass pins
☐ delamination/detachment ☐ spalling ☐ missing fragments ☒ other: mower damage

Soiling: ☒ biological ☐ staining ☐ efflorescence ☐ other:

Position: ☒ reset/level in ground ☐ reset/level to existing base ☐ construct new base ☐ resquare
☐ possible new base required ☐ stabilize foundation ☐ reset with NHL 3.5 1:2.5 mix ☐ reset with compound

Cost: \$150

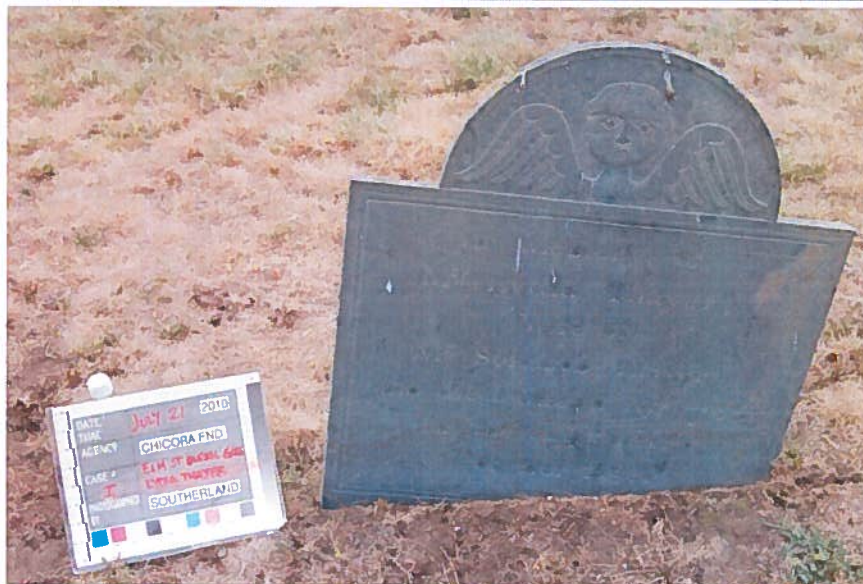
Section: I

Position: ☒ fallen ☐ tilted ☐ unstable ☐ unattached/loose ☐ missing ☒ moved behind headstone

Cost: \$450

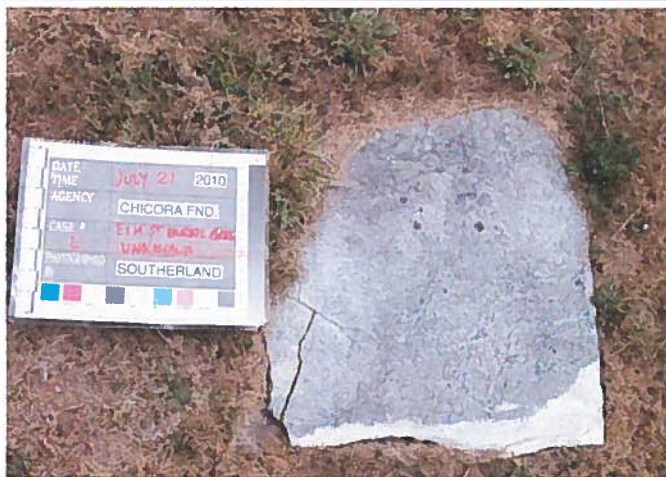
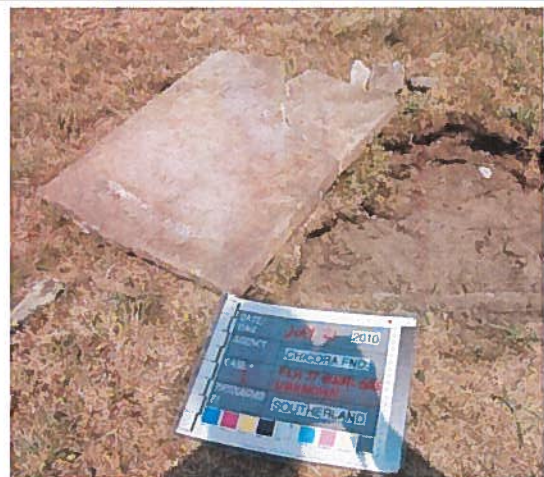
Section: L

Position: ☐ fallen ☐ tilted ☐ unstable ☐ unattached/loose ☐ missing

Legibility: ☐ sharp, tooling evident ☐ clear, but worn ☒ partially discernable ☐ not discernable

Deterioration: ☐ broken ☐ cracked ☐ losses ☐ flaking/sugaring ☐ ferrous pins ☐ brass pins
☐ delamination/detachment ☒ spalling ☐ missing fragments ☐ other:

Soiling: ☒ biological ☐ staining ☐ efflorescence ☐ other:

Treatment: ☐ core drill ☐ drill and pin ☐ simple adhesive repair ☒ injection grout ☐ replace bricks
☐ infill losses ☐ repoint ☒ other: consolidate with HCT

Cost: \$400

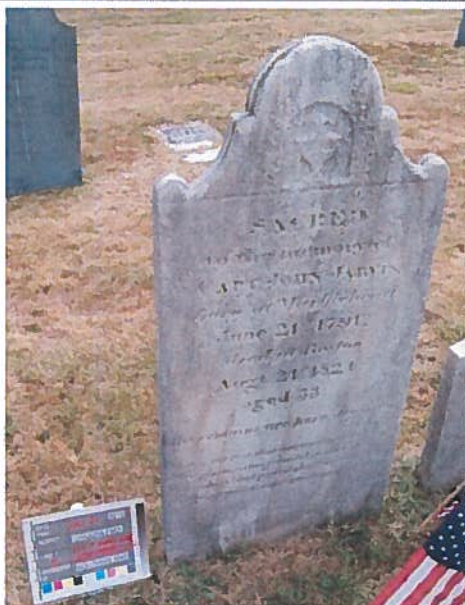
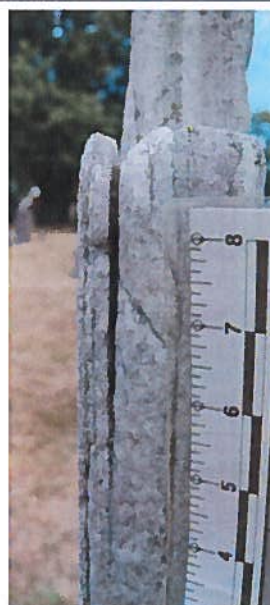
Section: L

Position: ☐ fallen ☐ tilted ☐ unstable ☐ unattached/loose ☐ missing ☒ moved behind headstone

Legibility: ☐ sharp, tooling evident ☐ clear, but worn ☒ partially discernable ☐ not discernable

Soiling: ☒ biological ☐ staining ☐ efflorescence ☐ other:

Position: ☐ reset/level in ground ☐ reset/level to existing base ☐ construct new base ☐ resquare
☐ possible new base required ☐ stabilize foundation ☐ reset with NHL 3.5 1:2.5 mix ☐ reset with
compound ☒ reset/level in ground ca. 5' behind headstone

Cost: \$150

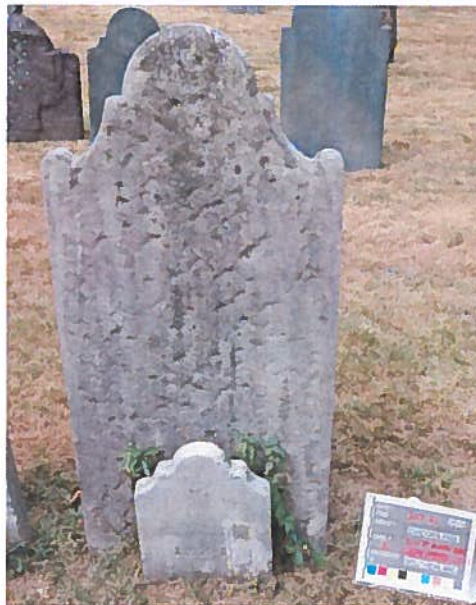
Section: L

Legibility: ☐ sharp, tooling evident ☐ clear, but worn ☒ partially discernable ☐ not discernable

Deterioration: ☐ broken ☐ cracked ☐ losses ☐ flaking/sugaring ☐ ferrous pins ☐ brass pins
☐ delamination/detachment ☐ spalling ☐ missing fragments ☒ other: weathered

Soiling: ☒ biological ☐ staining ☐ efflorescence ☐ other:

Treatment: ☐ core drill ☐ drill and pin ☐ simple adhesive repair ☐ injection grout ☐ replace bricks
☐ infill losses ☐ repoint ☒ other: consolidate with HCT

Cost: \$300

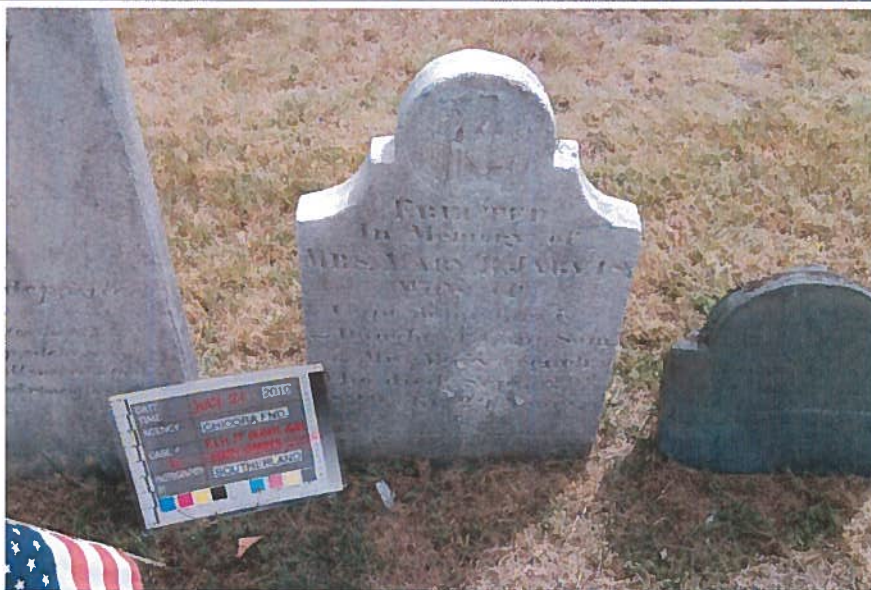
Section: L

Position: ☐ fallen ☐ tilted ☐ unstable ☐ unattached/loose ☐ missing ☒ moved behind headstone

Legibility: ☐ sharp, tooling evident ☐ clear, but worn ☐ partially discernable ☒ not discernable

Deterioration: ☐ broken ☐ cracked ☐ losses ☒ flaking/sugaring ☐ ferrous pins ☐ brass pins
☐ delamination/detachment ☐ spalling ☐ missing fragments ☒ other: heavy weathering

Soiling: ☒ biological ☐ staining ☐ efflorescence ☐ other:

Position: ☐ reset/level in ground ☐ reset/level to existing base ☐ construct new base ☐ resquare
☐ possible new base required ☐ stabilize foundation ☐ reset with NHL 3.5 1:2.5 mix ☐ reset with
compound ☒ reset/level in ground ca. 5' behind headstone

Treatment: ☐ core drill ☐ drill and pin ☐ simple adhesive repair ☐ injection grout ☐ replace bricks
☐ infill losses ☐ repoint ☒ other: consolidate with HCT

Cost: \$200

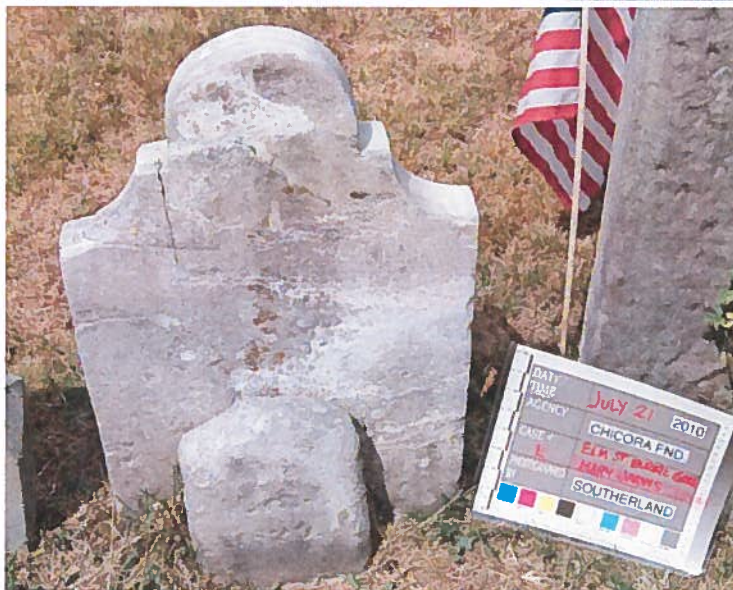
Section: L

Position: ☐ fallen ☒ tilted ☐ unstable ☐ unattached/loose ☐ missing ☒ moved behind headstone

Legibility: ☐ sharp, tooling evident ☒ clear, but worn ☐ partially discernable ☐ not discernable

Position: ☐ reset/level in ground ☐ reset/level to existing base ☐ construct new base ☐ resquare
☐ possible new base required ☐ stabilize foundation ☐ reset with NHL 3.5 1:2.5 mix ☐ reset with
compound ☒ reset/level in ground ca. 5' behind headstone

Cost: \$100

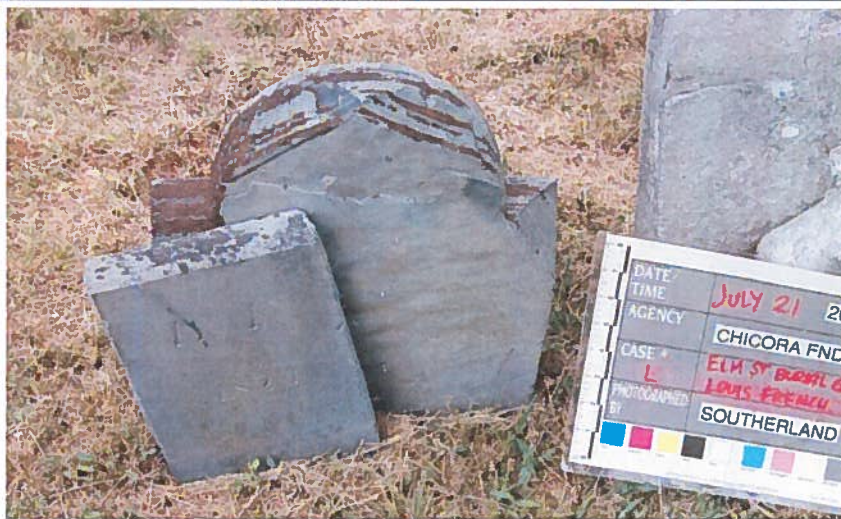
Section: L

Position: ☐ fallen ☐ tilted ☐ unstable ☐ unattached/loose ☐ missing ☒ moved behind headstone

Legibility: ☐ sharp, tooling evident ☐ clear, but worn ☐ partially discernable ☒ not discernable

Deterioration: ☐ broken ☐ cracked ☐ losses ☐ flaking/sugaring ☐ ferrous pins ☐ brass pins
☐ delamination/detachment ☐ spalling ☐ missing fragments ☒ other: weathered

Soiling: ☒ biological ☐ staining ☐ efflorescence ☐ other:

Position: ☐ reset/level in ground ☐ reset/level to existing base ☐ construct new base ☐ resquare
☐ possible new base required ☐ stabilize foundation ☐ reset with NHL 3.5 1:2.5 mix ☐ reset with
compound ☒ reset/level in ground ca. 5' behind headstone

Treatment: ☐ core drill ☐ drill and pin ☐ simple adhesive repair ☐ injection grout ☐ replace bricks
☐ infill losses ☐ repoint ☒ other: consolidate with HCT

Cost: \$200

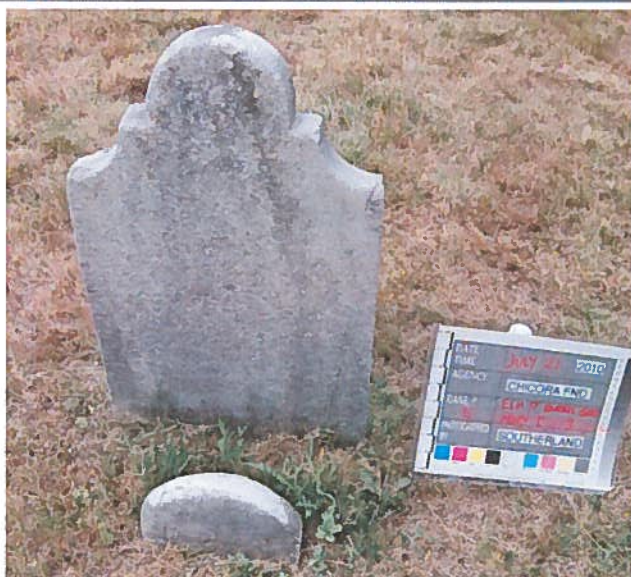
Section: L

Position: ☒ fallen ☐ tilted ☐ unstable ☐ unattached/loose ☐ missing

Legibility: ☐ sharp, tooling evident ☐ clear, but worn ☒ partially discernable ☐ not discernable

Deterioration: ☒ broken ☐ cracked ☐ losses ☐ flaking/sugaring ☐ ferrous pins ☐ brass pins
☐ delamination/detachment ☐ spalling ☐ missing fragments ☐ other:

Soiling: ☒ biological ☐ staining ☐ efflorescence ☐ other:

Position: ☐ reset/level in ground ☒ reset/level to existing base ☐ construct new base ☐ resquare
☐ possible new base required ☐ stabilize foundation ☐ reset with NHL 3.5 1:2.5 mix ☐ reset with compound

Treatment: ☐ core drill ☒ drill and pin ☐ simple adhesive repair ☐ injection grout ☐ replace bricks
☒ infill losses ☐ repoint ☒ other: consolidate with HCT

Cost: \$1200

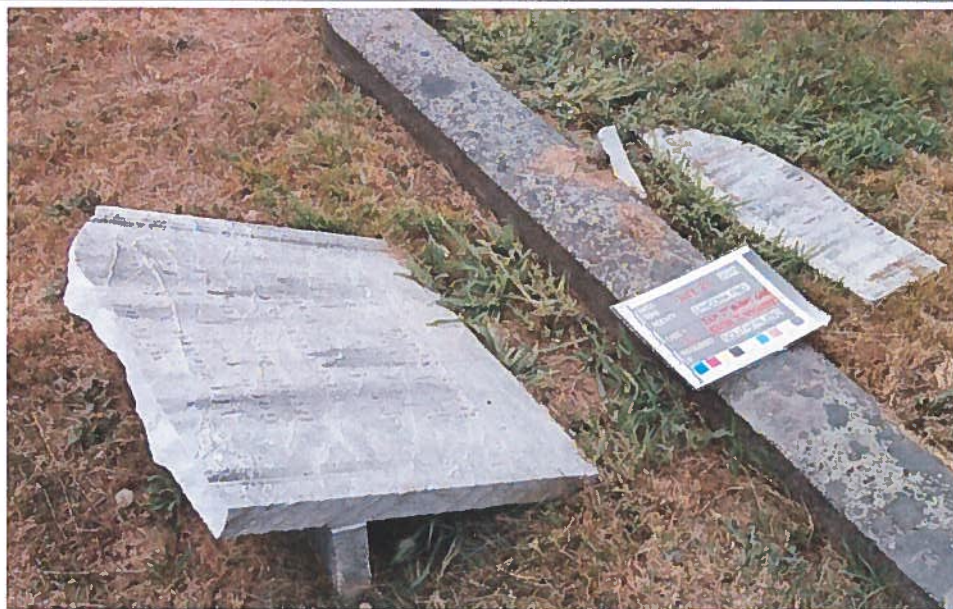
Section: M

Position: ☒ fallen ☐ tilted ☐ unstable ☐ unattached/loose ☐ missing

Legibility: ☒ sharp, tooling evident ☐ clear, but worn ☐ partially discernable ☐ not discernable

Deterioration: ☐ broken ☐ cracked ☐ losses ☐ flaking/sugaring ☐ ferrous pins ☐ brass pins
☐ delamination/detachment ☒ spalling ☐ missing fragments ☐ other:

Soiling: ☒ biological ☐ staining ☐ efflorescence ☐ other:

Treatment: ☐ core drill ☐ drill and pin ☐ simple adhesive repair ☒ injection grout ☐ replace bricks
☒ infill losses ☐ repoint ☐ other:

Cost: \$800

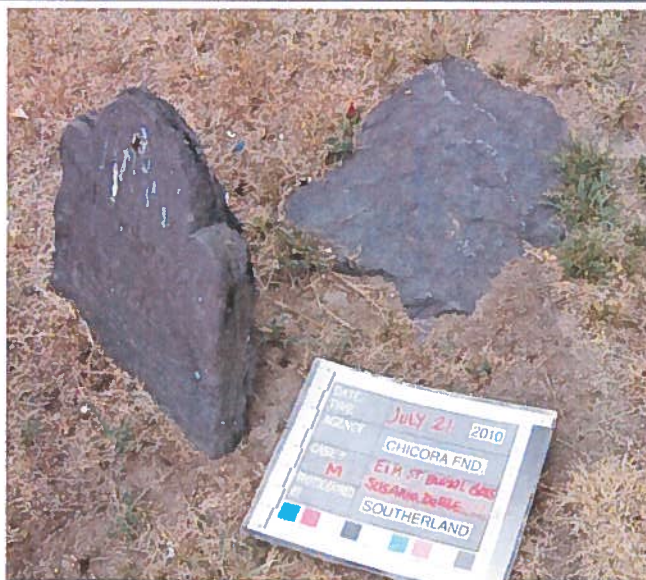
Section: M

Position: ☐ fallen ☐ tilted ☐ unstable ☐ unattached/loose ☐ missing ☒ moved behind headstone

Legibility: ☒ sharp, tooling evident ☐ clear, but worn ☐ partially discernable ☐ not discernable

Cost: \$100

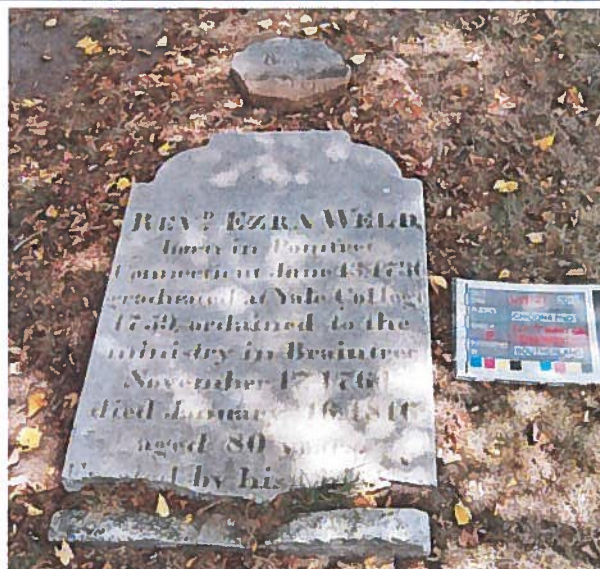
Section: P

Position: ☒ fallen ☐ tilted ☐ unstable ☐ unattached/loose ☐ missing

Legibility: ☐ sharp, tooling evident ☒ clear, but worn ☐ partially discernable ☐ not discernable

Deterioration: ☒ broken ☐ cracked ☐ losses ☐ flaking/sugaring ☐ ferrous pins ☐ brass pins
☐ delamination/detachment ☐ spalling ☐ missing fragments ☐ other:

Soiling: ☒ biological ☐ staining ☐ efflorescence ☐ other:

Position: ☐ reset/level in ground ☒ reset/level to existing base ☐ construct new base ☐ resquare
☐ possible new base required ☐ stabilize foundation ☐ reset with NHL 3.5 1:2.5 mix ☐ reset with compound

Treatment: ☐ core drill ☒ drill and pin ☐ simple adhesive repair ☐ injection grout ☐ replace bricks
☒ infill losses ☐ repaint ☒ other: consolidate with HCT

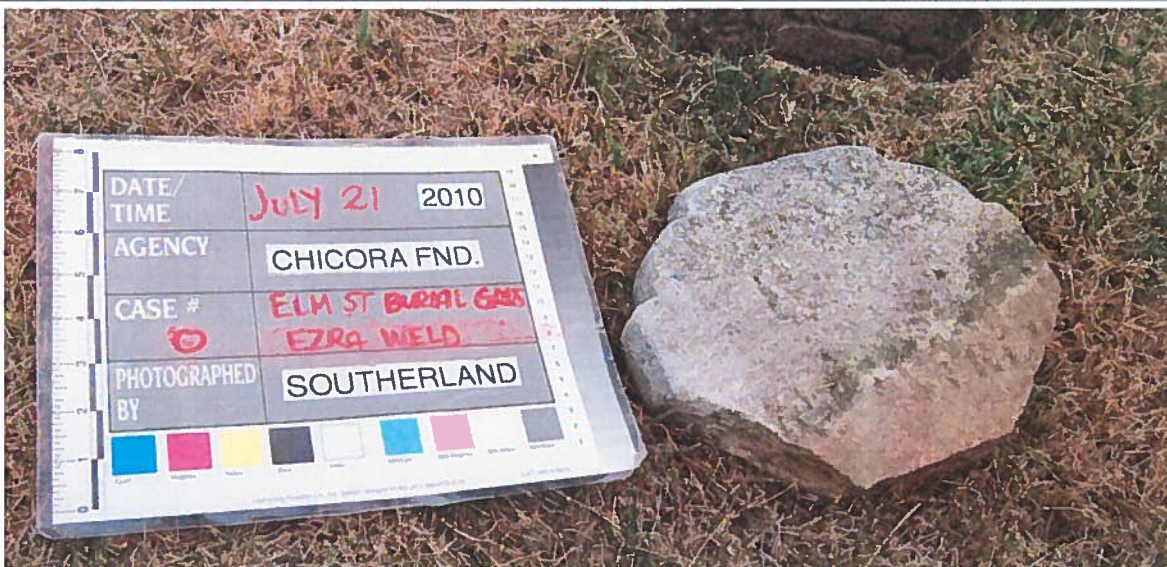
Section: P

Position: ☐ fallen ☐ tilted ☐ unstable ☒ unattached/loose ☐ missing ☒ moved behind headstone

Legibility: ☐ sharp, tooling evident ☐ clear, but worn ☒ partially discernable ☐ not discernable

Deterioration: ☒ broken ☐ cracked ☐ losses ☐ flaking/sugaring ☐ ferrous pins ☐ brass pins
☐ delamination/detachment ☐ spalling ☐ missing fragments ☐ other:

Soiling: ☒ biological ☒ staining ☐ efflorescence ☐ other:

Position: ☐ reset/level in ground ☐ reset/level to existing base ☒ construct new base ☐ resquare
☐ possible new base required ☐ stabilize foundation ☒ reset with NHL 3.5 1:2.5 mix ☐ reset with
compound ☒ reset/level in ground ca. 5' behind headstone

Treatment: ☐ core drill ☐ drill and pin ☐ simple adhesive repair ☐ injection grout ☐ replace bricks
☐ infill losses ☐ repoint ☒ other: consolidate with HCT

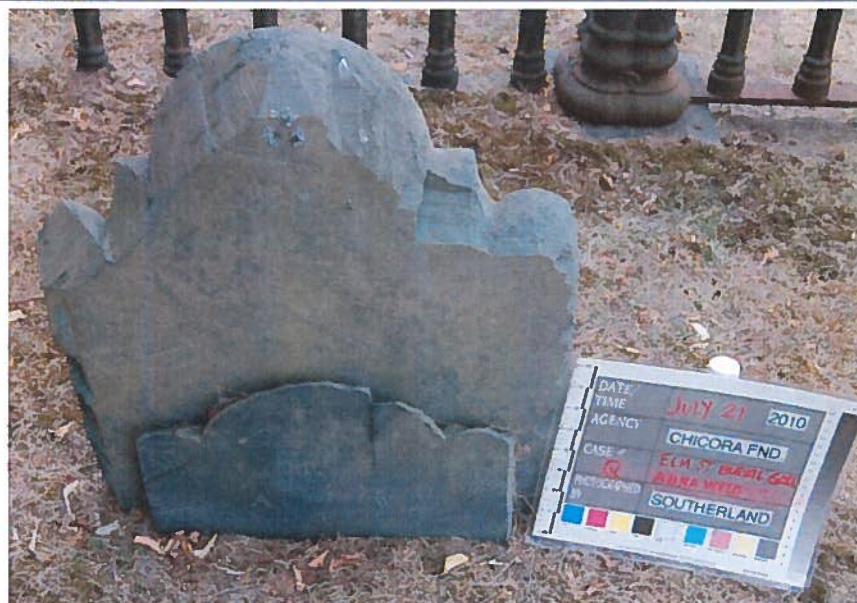
Section: Q

Position: ☐ fallen ☐ tilted ☐ unstable ☐ unattached/loose ☐ missing ☒ moved behind headstone

Position: ☐ reset/level in ground ☐ reset/level to existing base ☐ construct new base ☐ resquare
☐ possible new base required ☐ stabilize foundation ☐ reset with NHL 3.5 1:2.5 mix ☐ reset with
compound ☒ reset/level in ground ca. 5' behind headstone

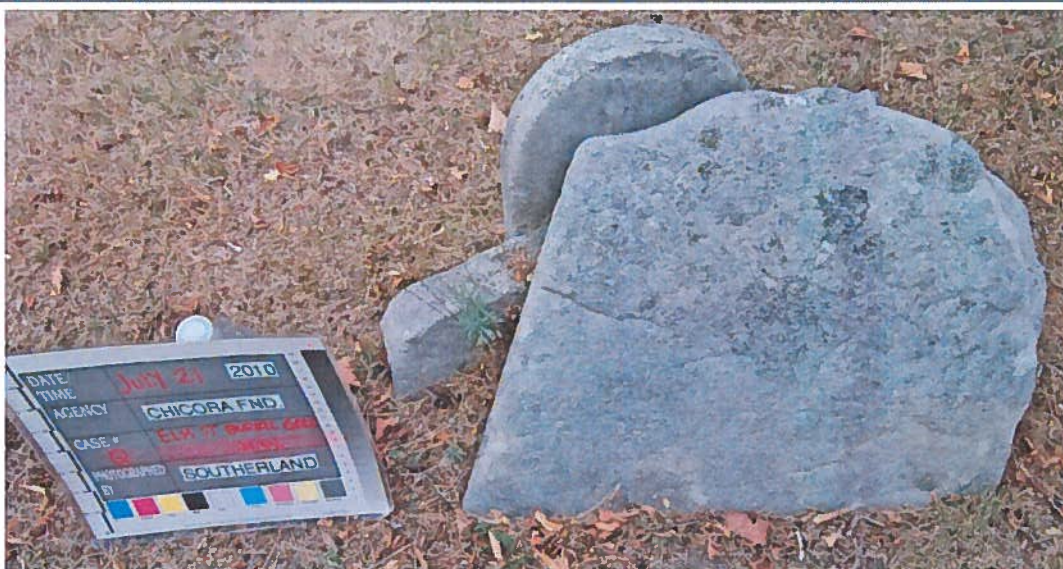
Section: Q

Position: ☒ fallen ☐ tilted ☐ unstable ☐ unattached/loose ☐ missing

Legibility: ☐ sharp, tooling evident ☐ clear, but worn ☐ partially discernable ☒ not discernable

Deterioration: ☒ broken ☐ cracked ☐ losses ☒ flaking/sugaring ☐ ferrous pins ☐ brass pins
☐ delamination/detachment ☐ spalling ☐ missing fragments ☐ other:

Soiling: ☒ biological ☐ staining ☐ efflorescence ☐ other:

Treatment: ☐ core drill ☒ drill and pin ☐ simple adhesive repair ☐ injection grout ☐ replace bricks
☐ infill losses ☐ repoint ☒ other: consolidate with HCT; consolidate with OH-100 if allowed

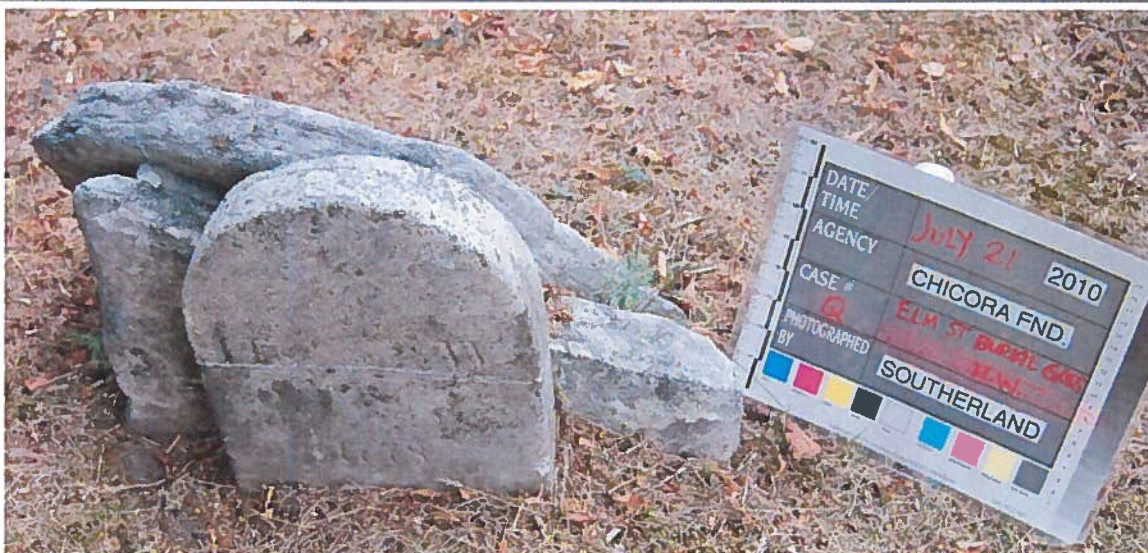
Section: Q

Position: ☐ fallen ☐ tilted ☐ unstable ☐ unattached/loose ☐ missing ☒ moved behind headstone

Legibility: ☐ sharp, tooling evident ☒ clear, but worn ☐ partially discernable ☐ not discernable

Position: ☐ reset/level in ground ☐ reset/level to existing base ☐ construct new base ☐ resquare
☐ possible new base required ☐ stabilize foundation ☐ reset with NHL 3.5 1:2.5 mix ☐ reset with
compound ☒ reset/level in ground ca. 5' behind headstone

Treatment: ☐ core drill ☐ drill and pin ☐ simple adhesive repair ☐ injection grout ☐ replace bricks
☐ infill losses ☐ repoint ☒ other: consolidate with HCT

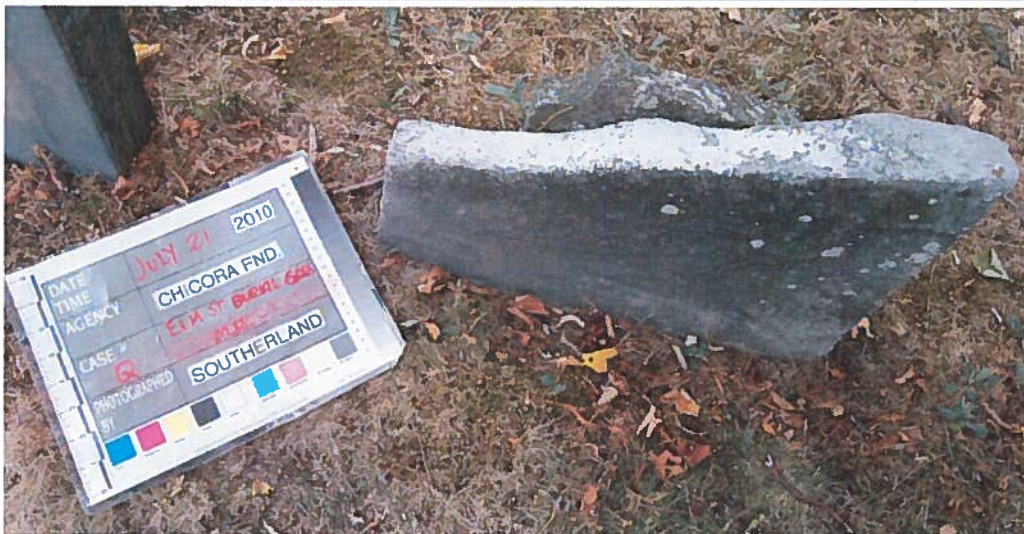
Section: Q

Position: ☐ fallen ☐ tilted ☐ unstable ☐ unattached/loose ☒ missing

Legibility: ☐ sharp, tooling evident ☐ clear, but worn ☐ partially discernable ☒ not discernable

Deterioration: ☒ broken ☐ cracked ☐ losses ☐ flaking/sugaring ☐ ferrous pins ☐ brass pins
☐ delamination/detachment ☐ spalling ☐ missing fragments ☒ other: top portion missing

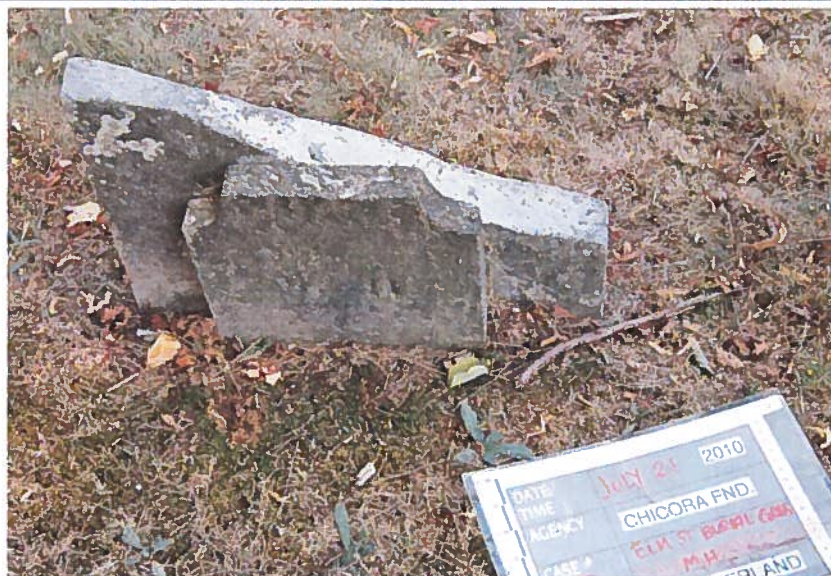
Section: Q

Position: ☐ fallen ☐ tilted ☐ unstable ☐ unattached/loose ☐ missing ☒ moved behind headstone

Legibility: ☐ sharp, tooling evident ☐ clear, but worn ☒ partially discernable ☐ not discernable

Soiling: ☒ biological ☐ staining ☐ efflorescence ☐ other:

Position: ☐ reset/level in ground ☐ reset/level to existing base ☐ construct new base ☐ resquare
☐ possible new base required ☐ stabilize foundation ☐ reset with NHL 3.5 1:2.5 mix ☐ reset with compound ☒ reset/level in ground ca. 5' behind headstone

Treatment: ☐ core drill ☐ drill and pin ☐ simple adhesive repair ☐ injection grout ☐ replace bricks
☐ infill losses ☐ repoint ☒ other: consolidate with HCT
